Concrete Pavement Restoration for Bonded Concrete Overlay of Asphalt Synthesis

Report No. NRRRA202001

Concrete Pavement Restoration (CPR) for Bonded Concrete Overlay of Asphalt (BCOA)

FINAL REPORT

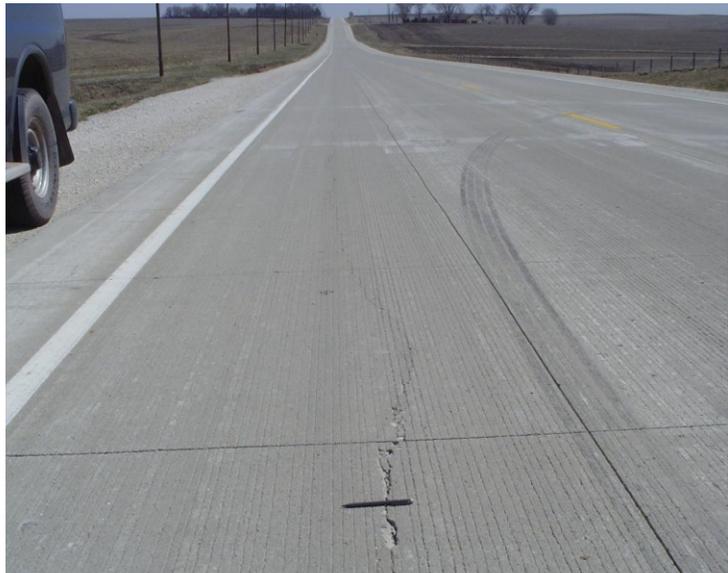
The most common distress that has been observed on several BCOAs in Iowa is longitudinal cracking in the outer wheel path and/or paved shoulder. This cracking has been observed in overlays with integral widening. When it occurs, this cracking usually appears within the first few years of service. An integral widening is a 2- to 3- foot widening of the mainline slab which helps to decrease edge stresses. The widenings are generally tied to the mainline overlay and constructed with increased thickness. Examples of this cracking are shown in **Figure 2.1** and **Figure 2.2**.

Figure 2.1 Longitudinal cracking in thin overlay with widening (Source: Kevin Merryman, Iowa DOT).

The longitudinal cracking is sometimes isolated to individual panels in the outer wheel path, but also sometimes runs continuously through a series of panels and extends into panels closer to the centerline.

For the most part, these longitudinal cracks are not severe and have not appeared to have much impact on PCI and/or IRI values measured for these overlay projects. However, most of these projects are still at an early age, so the condition of the overlays and cracked slabs must be monitored. On some of the relatively older projects, patching efforts have begun in some areas where cracks are beginning to spall and/or cause deterioration at joint intersections. Some details on the projects that have been patched in recent years are shown in **Table 2.1**.

On these projects, patching has been performed to the original depth of the overlay within individual panels or partial width of panels. These overlays are largely still in good condition, so the goal is to preserve condition and prevent distresses from becoming disruptive. A few examples of areas being prepared for patching on the U.S. 18 project are shown in **Figure 2.3** and **Figure 2.4**. Although the two projects highlighted (U.S. 18 and U.S. 65) are not typically considered as BCOAs, the significant thicknesses of the HMA interlayers justify their consideration as BCOAs.

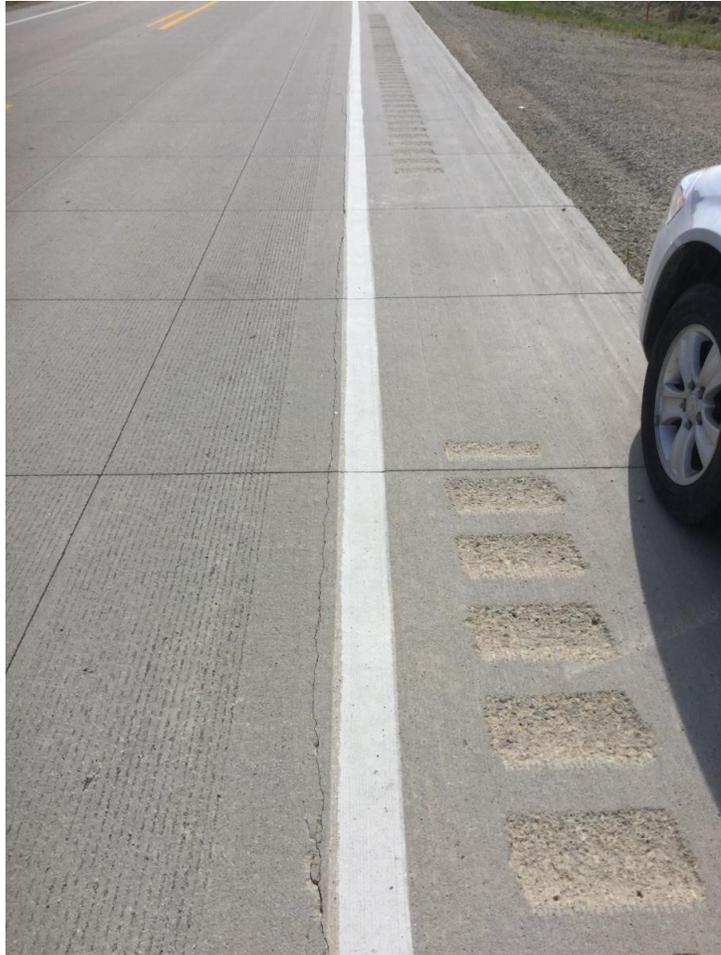
Figure 2.2 Longitudinal cracking in thin overlay with widening (Source: Kevin Merryman, Iowa DOT).

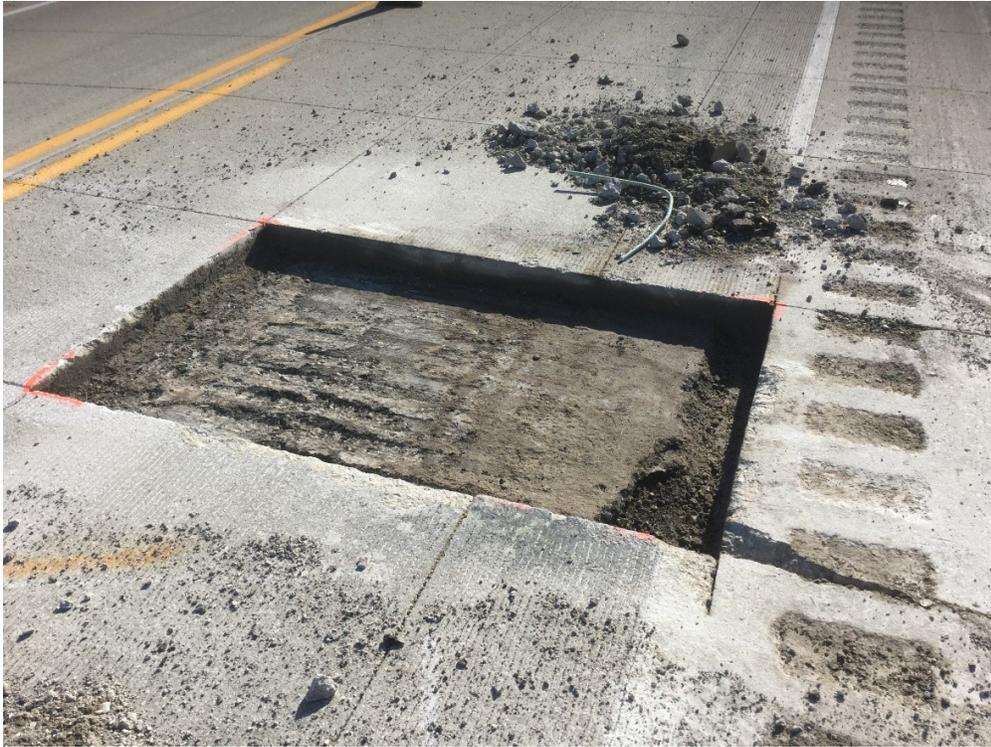
Figure 2.3 Example of patch area on U.S. 18 Project (Source: Kevin Merryman, Iowa DOT).

The U.S. 18 project repairs were done by contract and were spread out over the 19 total miles of the overlay project. While the total project cost for all of the repairs (including mobilization, flagging, pavement markings, etc.) totaled \$300,110, a breakdown of more specific line items are as follows: For full depth finish patching there were 599 square yards at a unit price of \$160.05 per square yard. For full depth finish patching (50 feet or greater in length) there were 88.9 square yards at a unit price of \$227 per square yard. For full depth patching by count, there were 206 at a unit price of \$109.82 per patch.

The U.S. 18 project has maintained stable ride quality in its most recent performance measurements from the Iowa Pavement Management Program (IPMP). The IRI in 2016 was 72.6 inches per mile and in 2018 was 76.0 inches per mile. PCI improved slightly over that time, from 82 percent to 86 percent. This improvement may be related to the repairs, as a decrease in longitudinal cracking and increase in count of patched slabs were observed in the IPMP data. Overall the cracking and repairs do not appear to have a major impact on ride quality, but patching activities may have helped improve PCI.

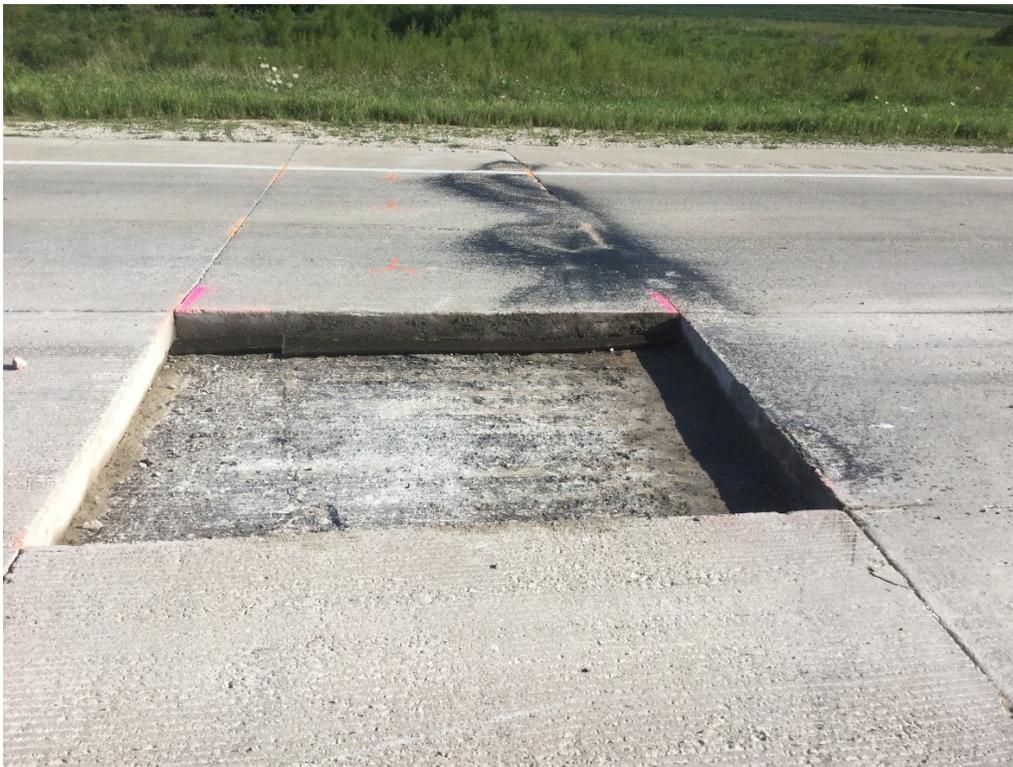
Figure 2.4 Example of patch area on U.S. 18 Project (Source: Kevin Merryman, Iowa DOT).

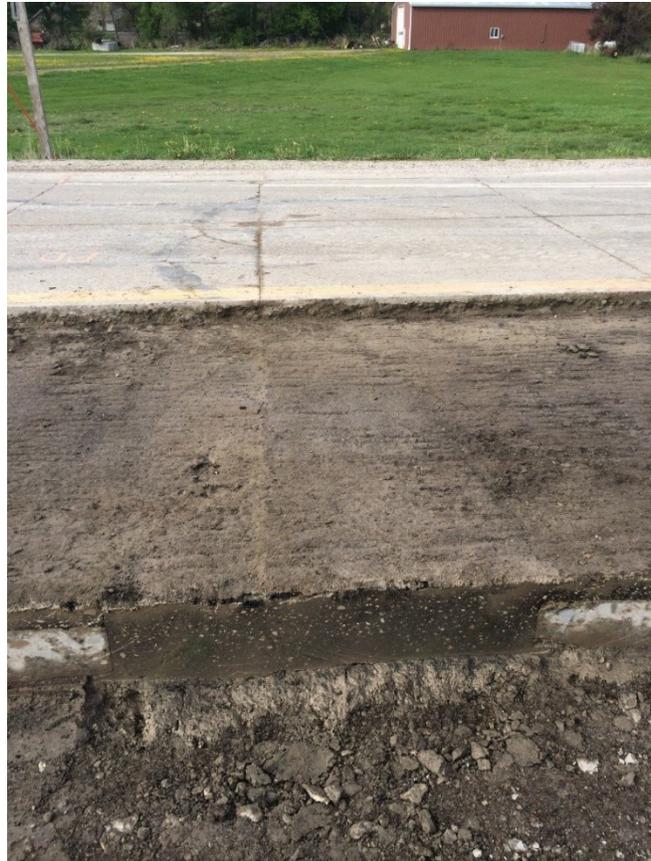
Examples are pictured in **Figure 2.5** and **Figure 2.6**. Note that the overlay is as thin as 3 inches (compared to 4.5-inch design thickness) in some areas where it has been removed. These thin areas were primarily concentrated in the portion of the project near the City of Odebolt. Similar isolated cracked slabs have been observed in thin spots in a short overlay project on Washington Street in the City of Iowa Falls as well.

Slab cracking was severe in these thin areas, so patching was required to improve the condition of the pavement. Since the overlay had been constructed too thin in these locations, an additional amount of asphalt had to be removed so that the patched portion of the overlay could be placed back at the design thickness. However, in areas where thickness was not a problem, only the overlay was patched.

Figure 2.5 Distressed area and overlay removal on IA 175 project (Source: Kevin Merryman, Iowa DOT).

The IA 175 project repairs were done by contract and consisted of both full depth and partial depth patching and was a spot repair concentrated in one area of the project. While the total project cost for all of the repairs (including mobilization, flagging, traffic control, etc.) totaled \$34,773.72, a breakdown of more specific line items are as follows: For full depth finish patching there were 74.7 square yards authorized at a unit price of \$184 per square yard. For full depth patching by count, there were 5 authorized at a unit price of \$180 per patch. For partial depth patching there were 343 square feet authorized at a unit price of \$20.44 per square foot.

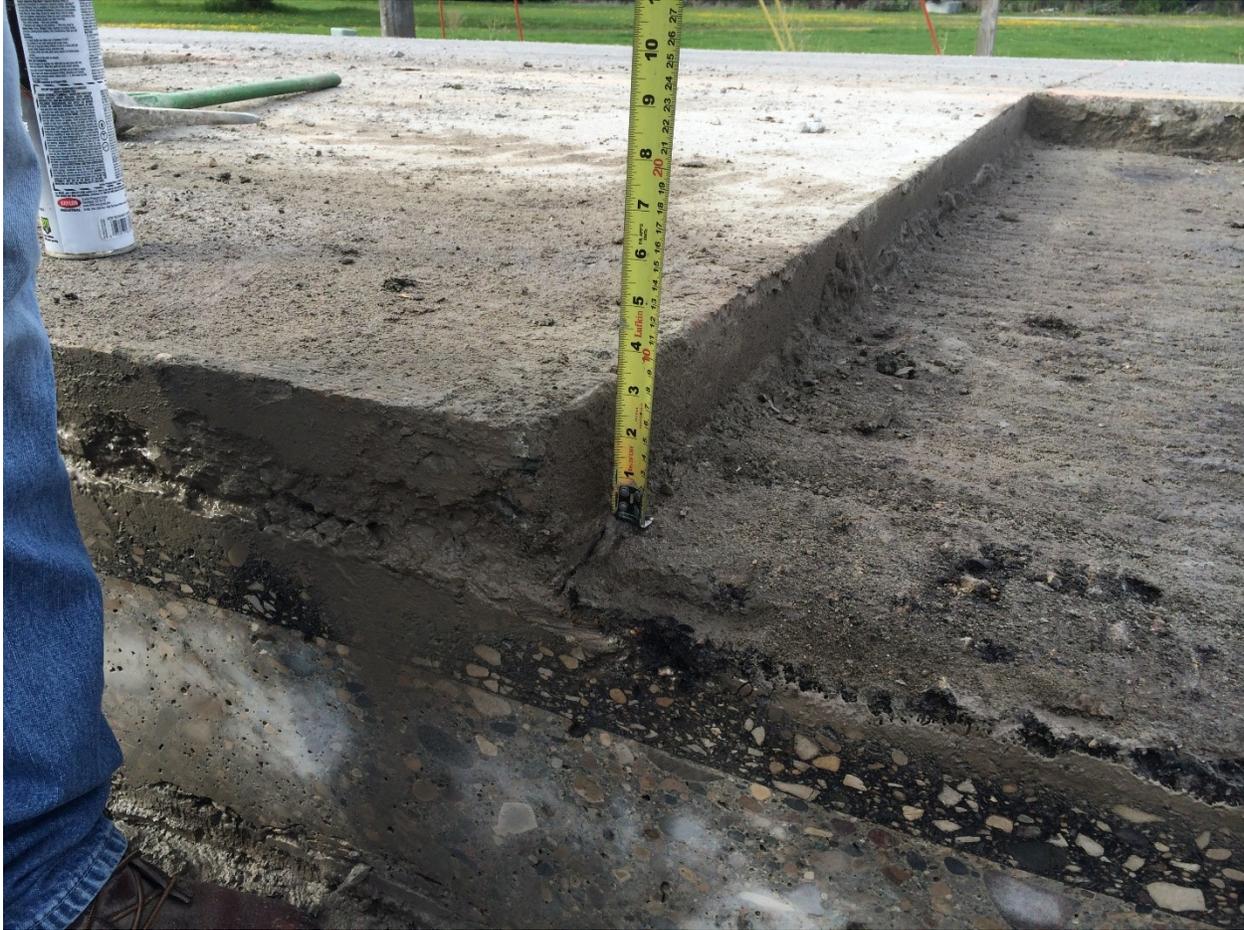
Figure 2.6 Removal showing thin area in overlay on IA 175 project (Source: Kevin Merryman, Iowa DOT).

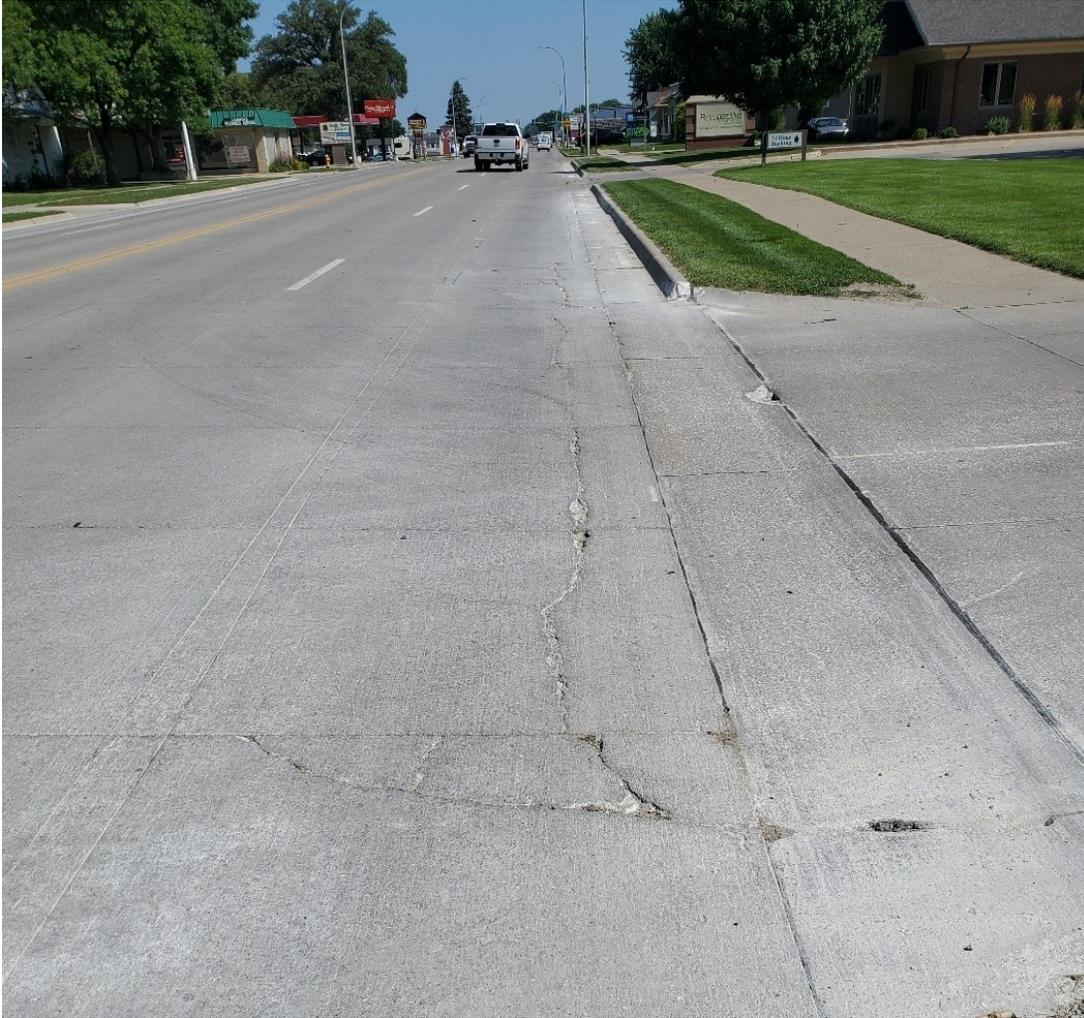
One other observed distress in Iowa BCOAs has been cracking at the pavement edge when the overlay is built as an inlay to match existing curb and gutter (**Figure 2.7**). When it occurs, this cracking tends to appear within the first few years of service life. The details of the project can be found in **Table 2.3**.

One of the causes of this cracking may stem from the different movement or restraint at the curb. The overlay was not tied to the existing curb and the existing curb was thicker than the overlay. Half-inch expansion joints have been added in the course of patching and repair. In some areas of this project, no curb was present or the existing curb was removed, and new integral curb was constructed with the overlay. In these areas, no distresses have been observed to date.

Another cause of this cracking may be due to the failure of geotextile fabric installed. The fabric was placed in areas where all existing HMA was milled out or chunked out during milling, which was more common on the outside edges of the pavement. There appeared to be voids underneath the fabric in some areas where cracking occurred, indicating the fabric may have been too thick in these areas to properly cover the existing pavement or relieve stresses. When patching slabs in areas where there had been fabric, in some cases fabric was not replaced, but instead curing compound was used to prevent bond, and in some cases the overlay patch was allowed to bond to the underlying concrete.

Figure 2.7 Longitudinal cracking adjacent to curb along Business Highway 75, Le Mars (Source: Iowa DOT).

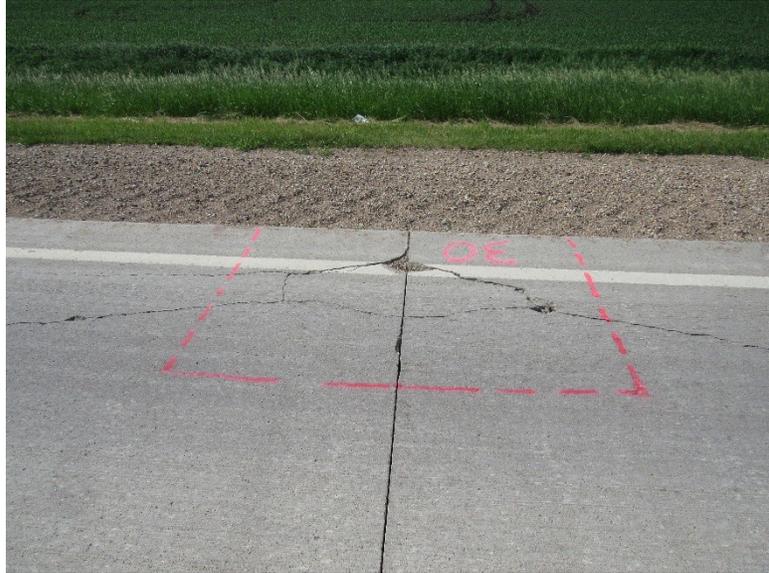
Several transverse cracks appeared right after paving and they were repaired in the spring of 2010 with typical concrete pavement full depth repairs. One year after the repair (2011), longitudinal cracks started to form along the inside dowel bar which then migrated to the mid-panel continuing longitudinally down the road each way. In 2014, pressure generated from the summer expansion on areas where dowel baskets were located was causing concrete to break loose at the cracks (**Figure 2.8**).

Figure 2.8 Longitudinal cracks observed on BCOA panels (Source: Freeborn County, MN).

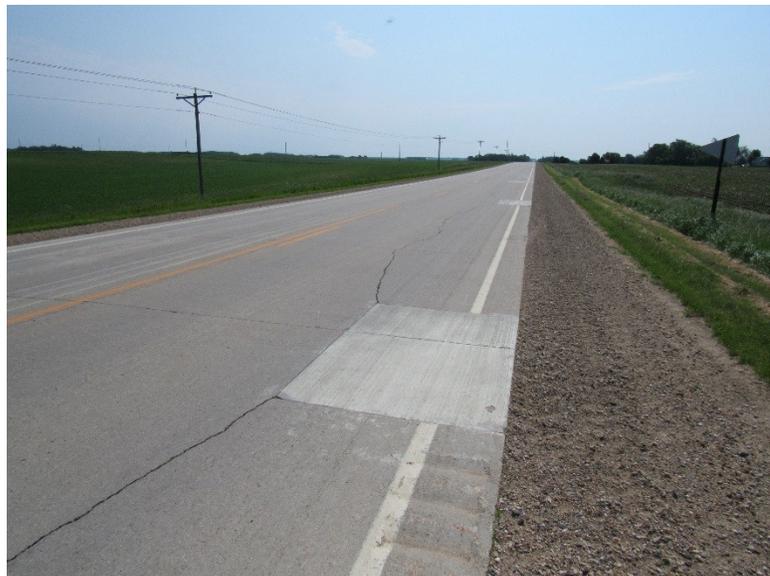
Figure 2.9 Repairs performed on BCOA panels (Source: Freeborn County, MN).

Repairs were performed by sawing out the bad areas, approximately 2- to 3-feet from each side of the transverse joint, and the corners of the removed area would match to the existing longitudinal cracks (**Figure 2.9**). The full-depth repairs included removing the existing dowel baskets with no replacement, followed by sawing the transverse joint to

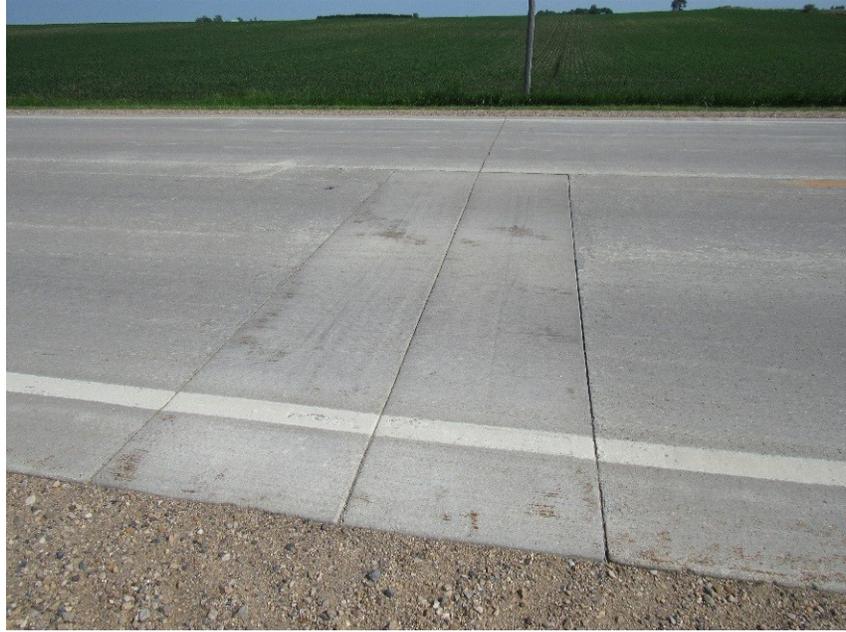
Figure 2.10 Full-depth repairs performed on BCOA panels (Source: Freeborn County, MN).

match the old joint (**Figure 2.10**). This repair project was performed from Alden heading east for about 1.3 miles, with a cost about \$75,000 per mile.

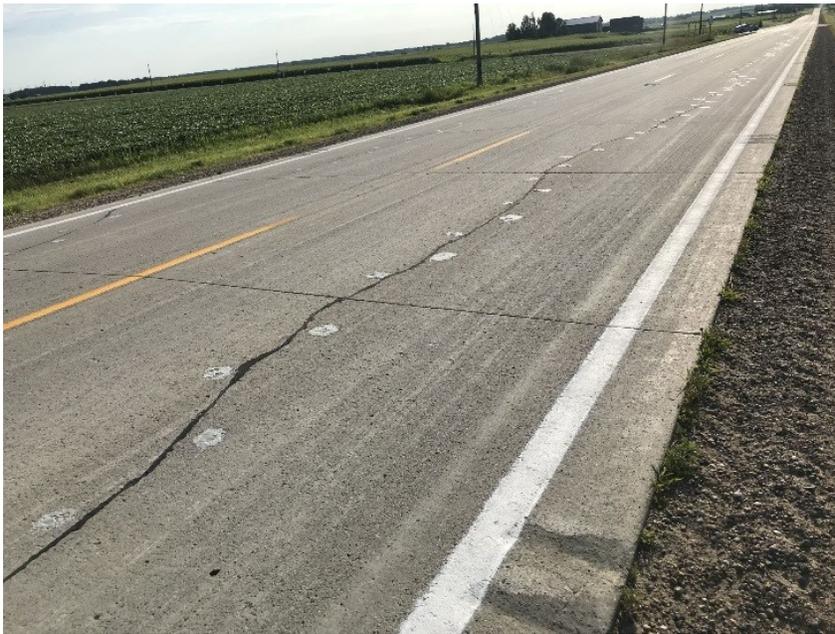
Figure 2.11 Longitudinal cracks sealed and cross-stitched (Source: Freeborn County, MN).

In 2015, the longitudinal cracks had extended the entire length of the road, so the decision was made to cross-stitch and seal the longitudinal cracks (**Figure 2.11**). The plan was to start the repairs from CSAH 14 heading west, repairing approximately one mile of roadway per year in 2015, 2017, and 2018. The pavement has not moved as much in the areas of stitching and the cost was about

\$100,000 per mile. From the pavement management data in 2018, the international roughness index (IRI) was 80- to 90-inches per mile in the affected area, which was equivalent to a MnDOT Ride Quality Index (RQI) values of 3.3 to 3.5. The ratings indicated the road was in good condition according the MnDOT's performance categories. Due to the thickness of the overlay (6"), standard concrete pavement repair techniques were used.

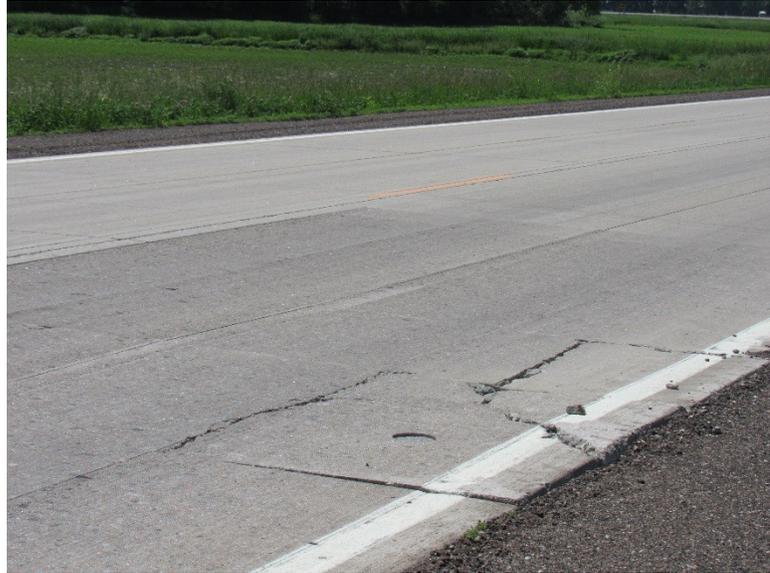
McLeod County has done repairs to address early joint faulting of BCOA, as well as buckled slabs and cracked panels (**Figure 2.12**). Full width panel replacement was performed as a repair (**Figure 2.13**).

Figure 2.12 Cracked panels on CSAH 7 in Hutchinson, McLeod County (Source: McLeod County, MN).

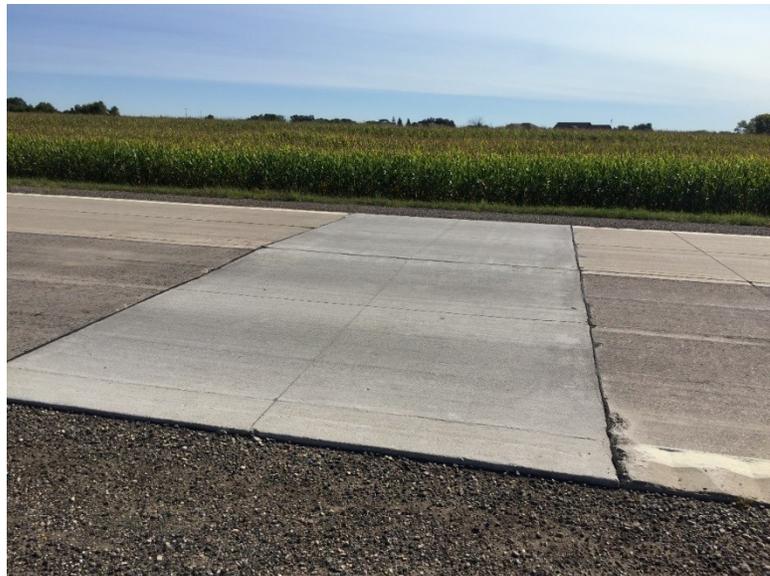
Figure 2.13 Full width panel replacement on cracked panels as shown in Figure 2.12 (Source: McLeod County, MN).

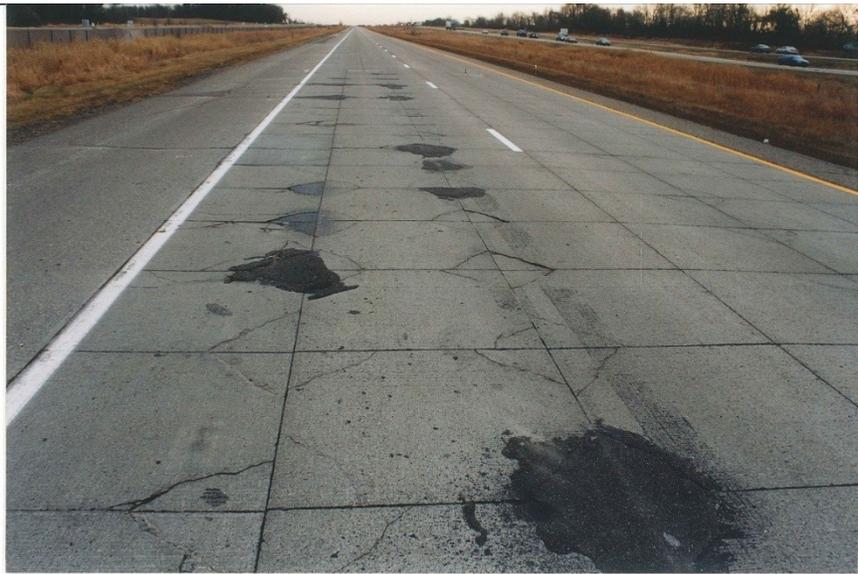
MnDOT has experimented with BCOA repairs at MnROAD. Test sections of ultra-thin whitetopping with a panel size of 4 feet by 4 feet were constructed in 1997 at MnROAD. The longitudinal edges of the panels were located along the wheelpaths due to the size of the panel, which resulted in high edge stresses. By November 2003, the corner cracks that developed were severe and extensive. Asphalt patching was performed on the distressed panels during the summer of 2004 (**Figure 2.14**). The ride quality was becoming a concern, thus live interstate traffic was removed from these test sections in 2004 (Burnham, T., 2005).

Figure 2.14 BCOA panels, constructed in 1997, failed at MnROAD in 2003 and asphalt patching was performed on the distressed panels in 2004 (Source: MnDOT).

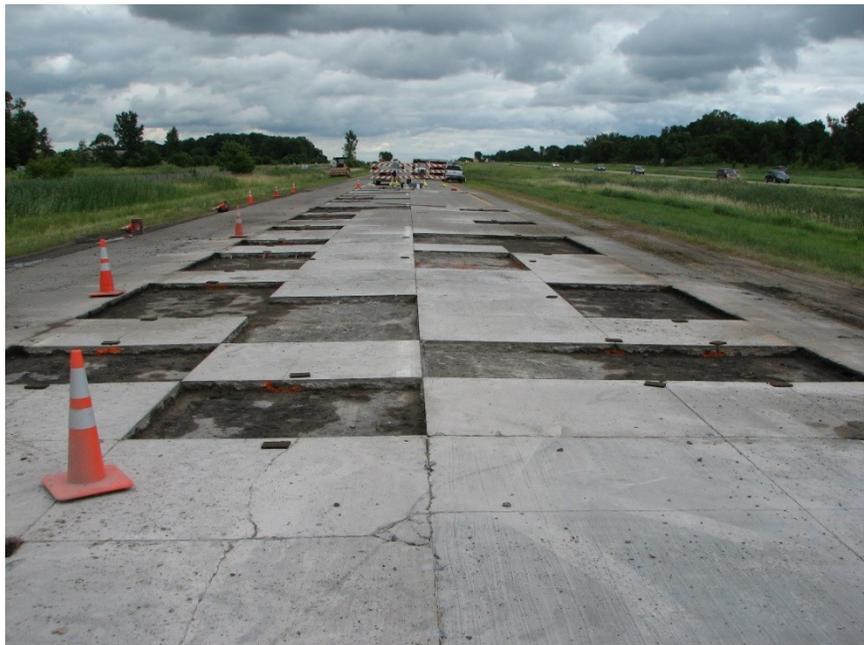
In 2004, new test sections of 4-inch whitetopping were built at MnROAD, with a panel size of 6 feet by 5 feet. Panels that failed were scheduled for repair in 2011 (**Figure 2.15**) and the causes for the distress were a combination of fatigue cracking due to inadequate overlay thickness and loss of panel bonding with the HMA due to lack of joint seals.

Figure 2.15 Panel replacement performed at MnROAD in 2011 on BCOA panels, which were constructed in 2004 (Source: MnDOT).

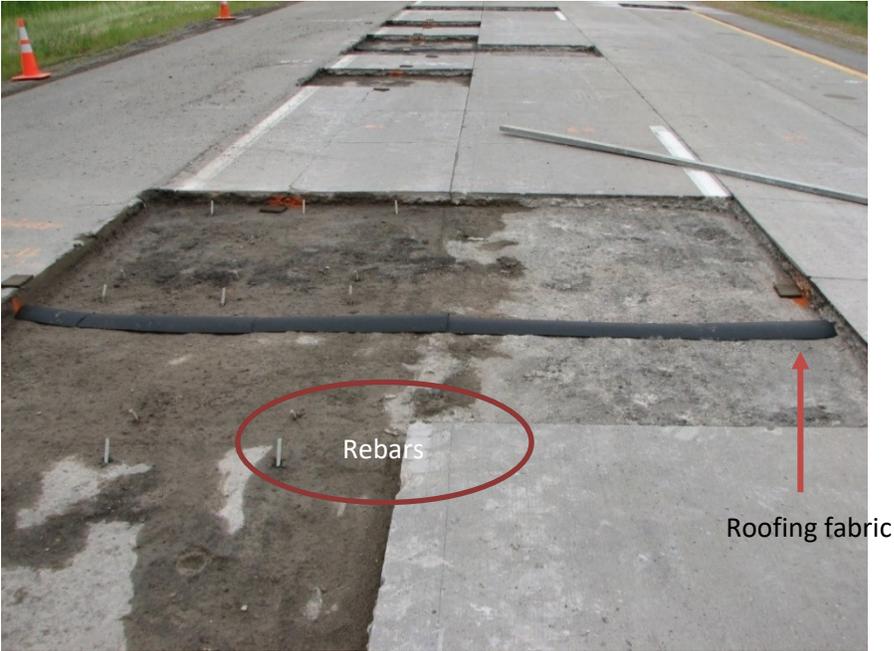
Figure 2.16 Repair included rebars installed into the asphalt to enhance bond, and a strip of roofing fabric placed to mitigate reflective cracks (Source: MnDOT).

Rebars were installed at an angle into the underlying asphalt pavement to aid bonding and strips of roofing fabric was installed to retard reflective cracking (**Figure 2.16**). **Figure 2.17** showed the performance of repair two years later (in 2013). The leading-edge distress on the repaired panel may be caused by the rebar, while the strip of roofing fabric seems to be effective in mitigating reflective cracks.

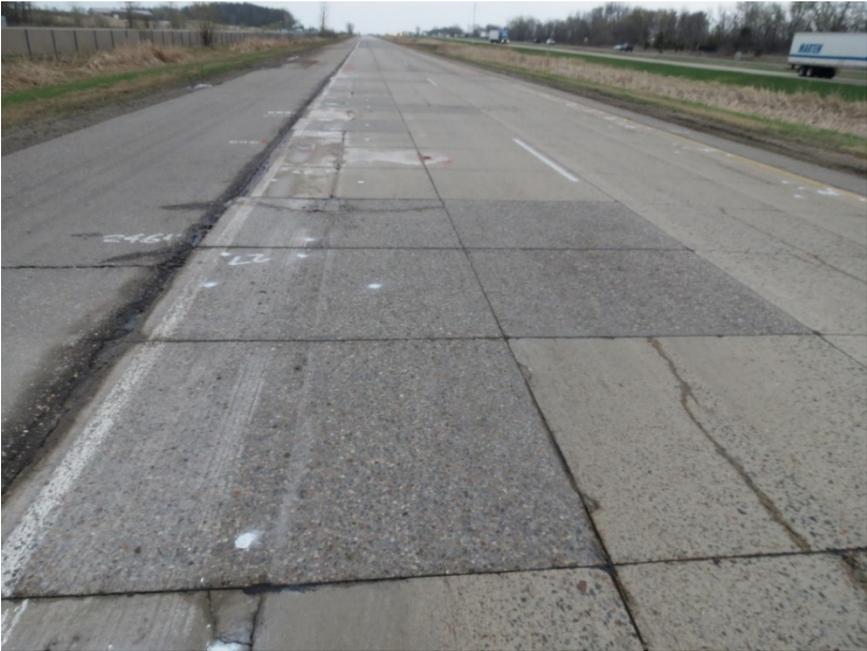
Figure 2.17 Performance of repairs after 2 years (Source: MnDOT).

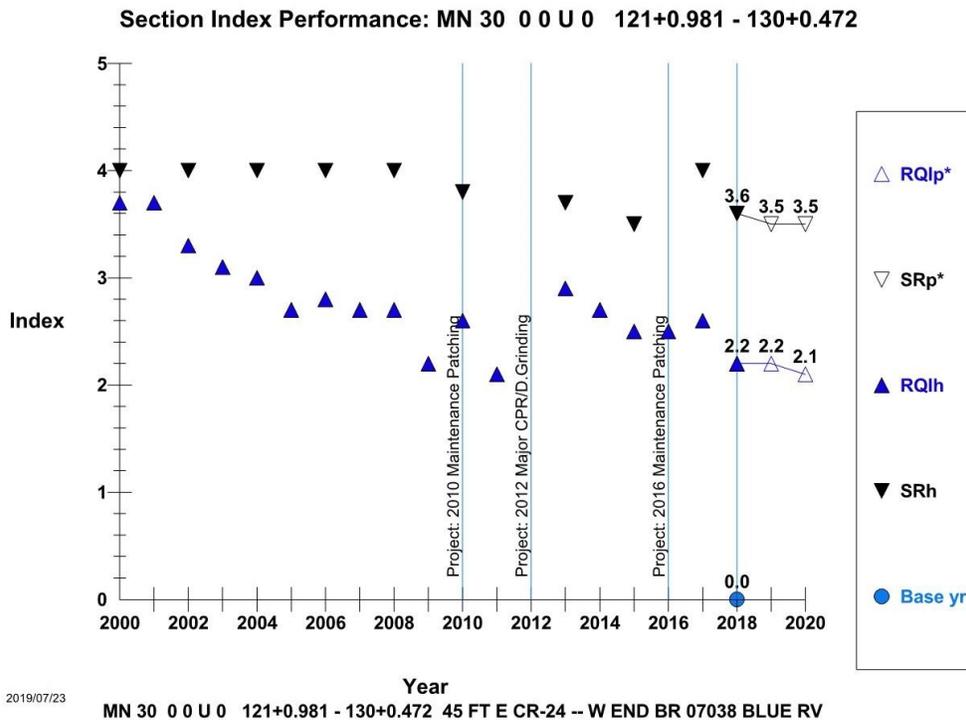
Since it was originally constructed, there were a few maintenance and rehabilitations performed on the road. Maintenance patching was performed in 2010 and 2016, while major CPR and diamond grinding were performed in 2012. **Figure 2.18** showed pavement performance in terms of Ride Quality Index (RQI) and Surface Rating (SR) obtained from MnDOT District 7. RQI has a scale of 0 to 5, which higher RQI represents smoother road. SR is determined based on the pavement distresses and it ranges from a 0 to 4 scale. A higher SR represents road in better condition. Both RQI and SR have terminal values of 2.5. *MnDOT 2019 Pavement Condition Annual Report* stated that "Pavements are normally designed for a terminal RQI value of 2.5. When a road has reached its terminal RQI value it does not mean the road cannot be driven on, but rather that it has deteriorated to the point where most people feel it is uncomfortable and a major rehabilitation is likely needed."

The major CPR and diamond grinding conducted in 2012 improved the ride quality of the BCOA pavement to above the threshold of 2.5 for a few years before needing another minor repair (maintenance patching).

Figure 2.18 Pavement performance along TH 30 obtained from MnDOT District 7 (Source: MnDOT District 7).

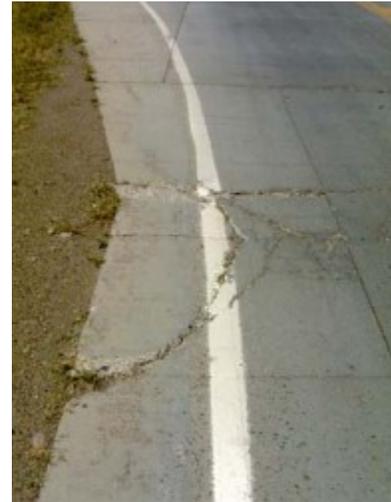
Multiple panels at the north end and south end of the project were selected for repair. There were various causes for the development of cracks. Areas where cracks formed near curb edges might be due to the lack of support, and the turning motions of heavy trucks would have aggravated the issue. Cracks were initially recorded in 2002 and had continually deteriorated until repair was needed in 2005 (**Figure 2.19**).

Figure 2.19 Panels that needed repair in 2005 (Source: Montana DOT).

Repair conducted in 2005 involved the removal of the full depth of BCOA (including the concrete overlay and underlying existing asphalt) and the replacement with full depth PCC pavement. This repair section had been performing well to date from the follow up phone call with the DOT carried out in January 2020. The AADT for the past five years was at 4,380 with 15% truck traffic.

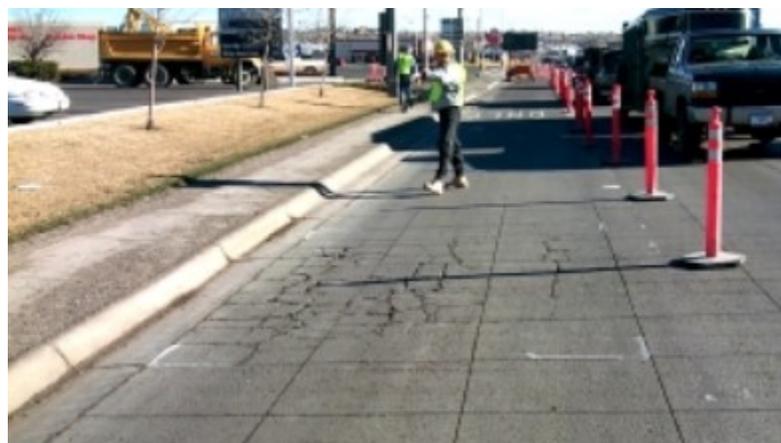
developed on multiple panels (Source: Montana DOT).

and shoving of the existing asphalt pavement at the intersection. Late summer the next year (2000), multiple panels located on the right-turn lane exhibited severe cracking (**Figure 2.20**). The premature failure of the pavement was determined to be support issues where there was too much moisture in the subgrade and the subgrade material was not able to provide support for the structure. In addition to that, the existing asphalt pavement was observed to have extreme stripping issues.

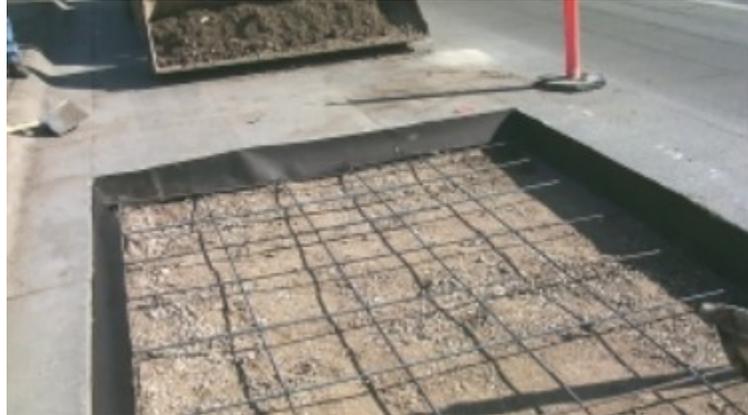
Figure 2.21 Tar paper and rebar installed within the repair area (Source: Montana DOT).

A full depth panel removal and replacement was performed in 2001. Subgrade correction was conducted by removing several feet of the existing subgrade material followed by replacing it with 1.5-inch minus aggregate fill material. Geotextile fabric was installed prior to the placement of the new fill to minimize the contamination of fines into the fill material.

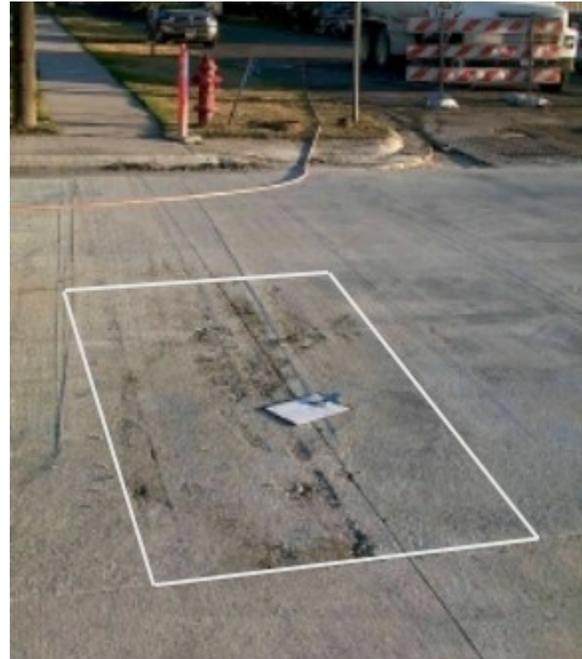
Figure 2.22 The unconsolidated spot during construction (Source: Montana DOT).

The unconsolidated section was removed. Two alternative repairs were to remove and replace the full depth of BCOA (both concrete overlay and underlying existing asphalt) with PCC pavement or to just replace the layer of concrete overlay with epoxy-coated reinforcing bars installed. The latter (**Figure 2.23**) was selected to promote transfer of loading between the panels. Joints were established the same as prior to removal.

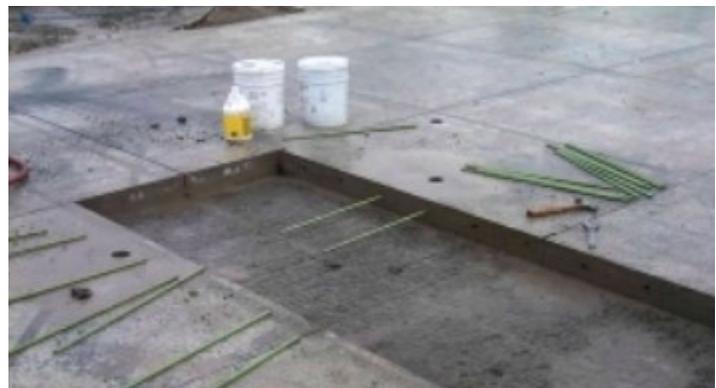
During 2010 evaluation, this repair section was observed to be performing well with no visual distresses observed and exhibiting no faulting or movement of the slab. This repair section had been performing well to date from the follow up phone call with the DOT carried out in January 2020. The AADT for the past five years was at 24,770 with 18 percent truck traffic.

Figure 2.23 Repair performed on the unconsolidated spot (Source: Montana DOT).

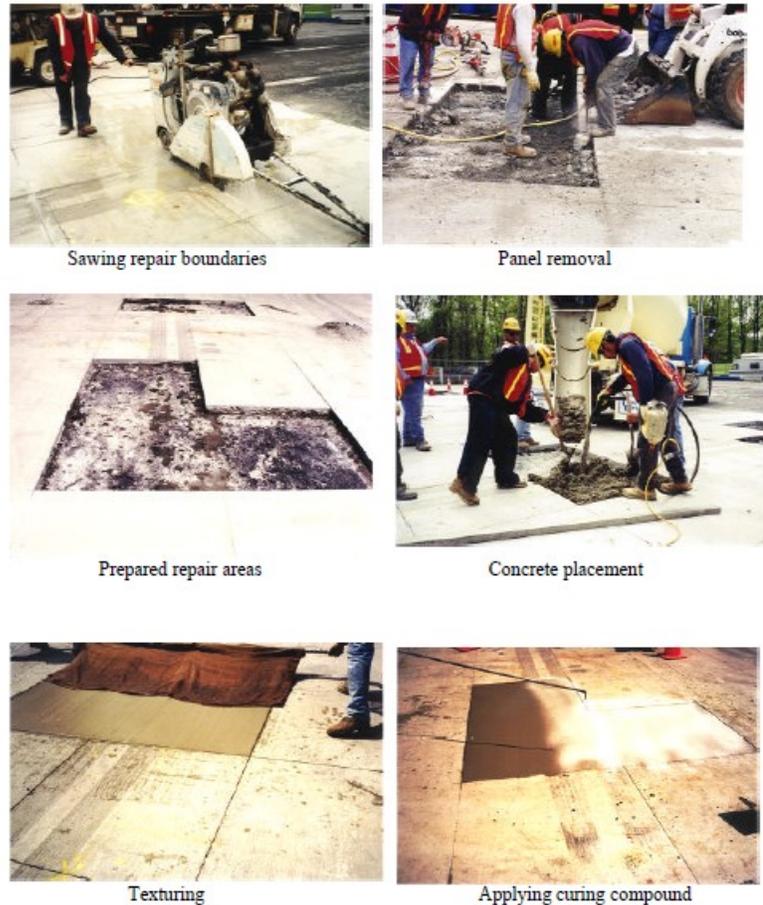
ALF load testing was conducted using dual wheels with a gross load of 53.4 kN on the repaired panels eight days after the repair. The first cracks appeared after 66,700 load passes (Lane 6) and 50,000 load passes (Lane 10). The design load repetitions for the test sections were 255,000 and 441,000 for Lane 6

Figure 3.1 Photos obtained from the report showing the repair work (Source: Sheehan, Sherwood, Tayabji, & Wu, 2001).

and Lane 10 respectively. At the end of the loading tests, Lane 6 test section was subjected to 400,000 load passes while Lane 10 test section was subjected to 427,000 load passes. Half of the repaired panels exhibited cracks and majority of the cracks were closely held together. Nonetheless, the repaired panels seemed to be performing well.

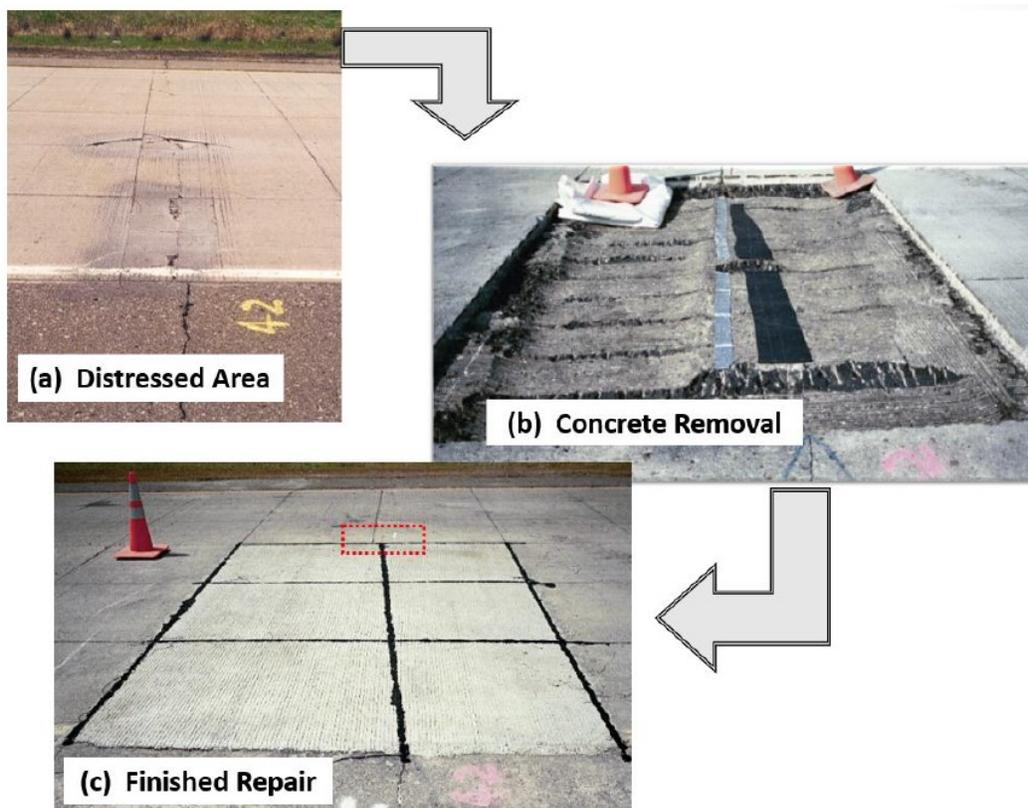
Figure 3.2 Photos obtained from the report showing the repairs done on panels with reflective cracking (Source: Sachs & Vandenbossche, 2013).

Full-depth patching should be performed only on isolated panels where distresses are encountered. Panels should not be replaced with asphalt materials since there will be bonding issues between asphalt patching and surrounding concrete panels due to the movements of concrete panels. Extra care needs to be taken to repair concrete panels. If removed, a debonding material should be placed over the crack (Figure 3.2(b)) in the asphalt surface to break the bond in the immediate area surrounding the crack. Figure 3.2 (c) shows that the transverse joint in the repair was sawed directly above the crack. In this case, the longitudinal joints should be sawed full depth to prevent the cracks from developing due to the misaligned transverse joints of the repaired panels and the adjacent existing panels.
